BUILDING ENGINEERING REPORT (BER)

Building Name: Federal Building – 517 Gold Avenue SW
 Building No.: NM0024ZZ
 Location: Albuquerque, New Mexico

Title: Public Area Remodel – First Floor Lobby and Corridors

Title: Public Area Remodel - Eight Floor Lobbies, Corridors and Two Stairwells

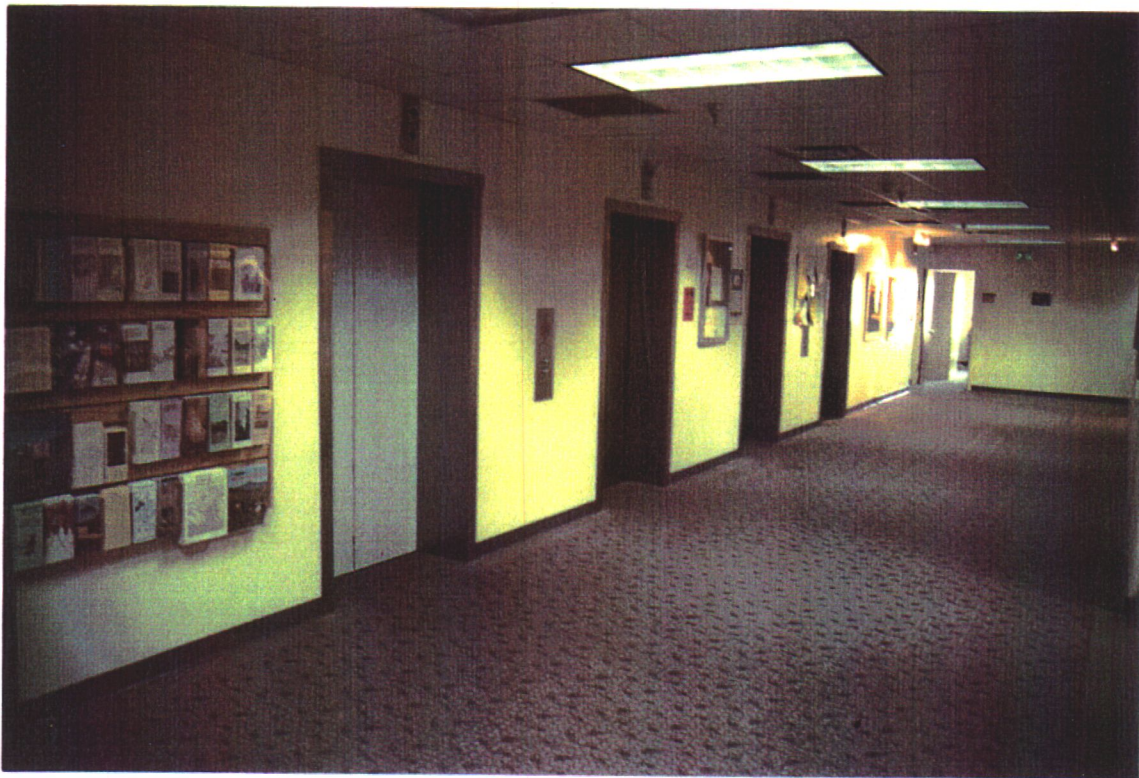
The existing secondary elevator lobbies and public corridors (basement, floors 2 through 8) vary from floor to floor in appearance. The elevator lobbies provide a first impression to new tenants and visitors. The lobbies function as a space to become oriented to find a tenant location on the floor.

Lobbies' plain, dated finishes which include carpet, paint and suspended ceiling tile show wear and age and need to be replaced. This will include new ceilings with different heights and new cove lighting. The existing stairwells need improved lighting and new brighter paint.

Typical Lobby Above First Floor

As part of modernization of facility; replace and upgrade finishes to give a first impression to visitors and tenants and to remain competitive.

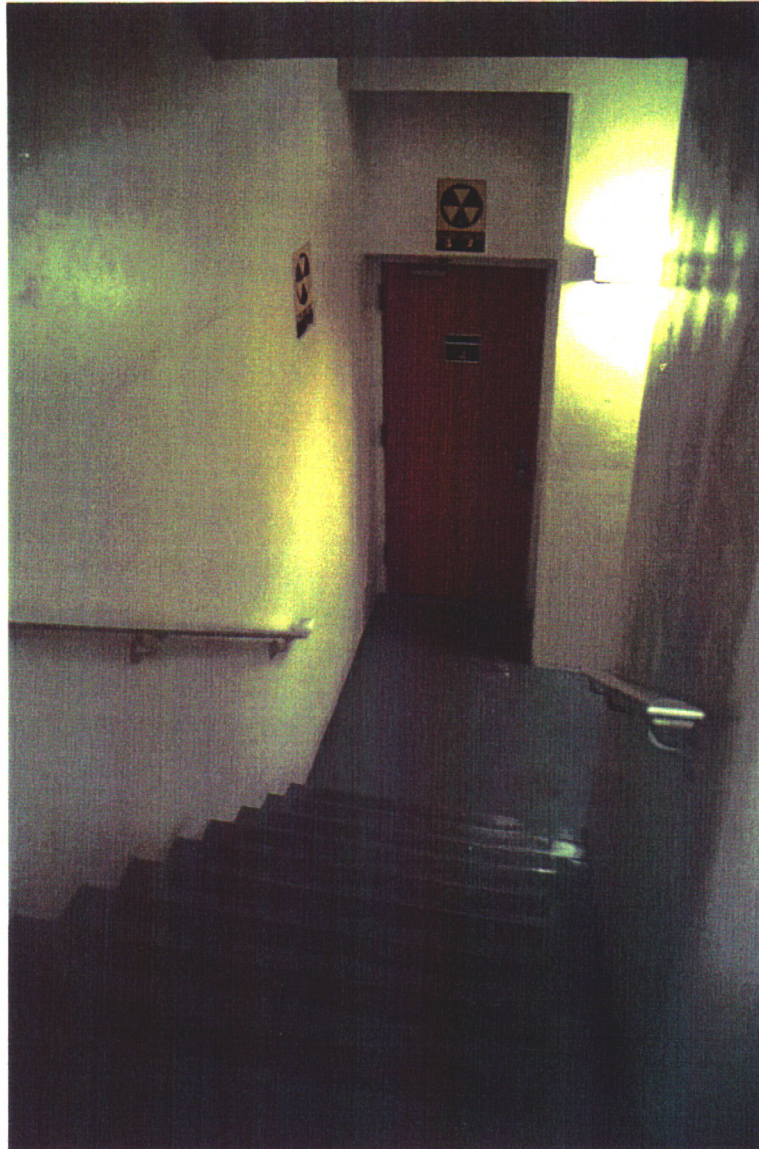
Typical Exit Stair

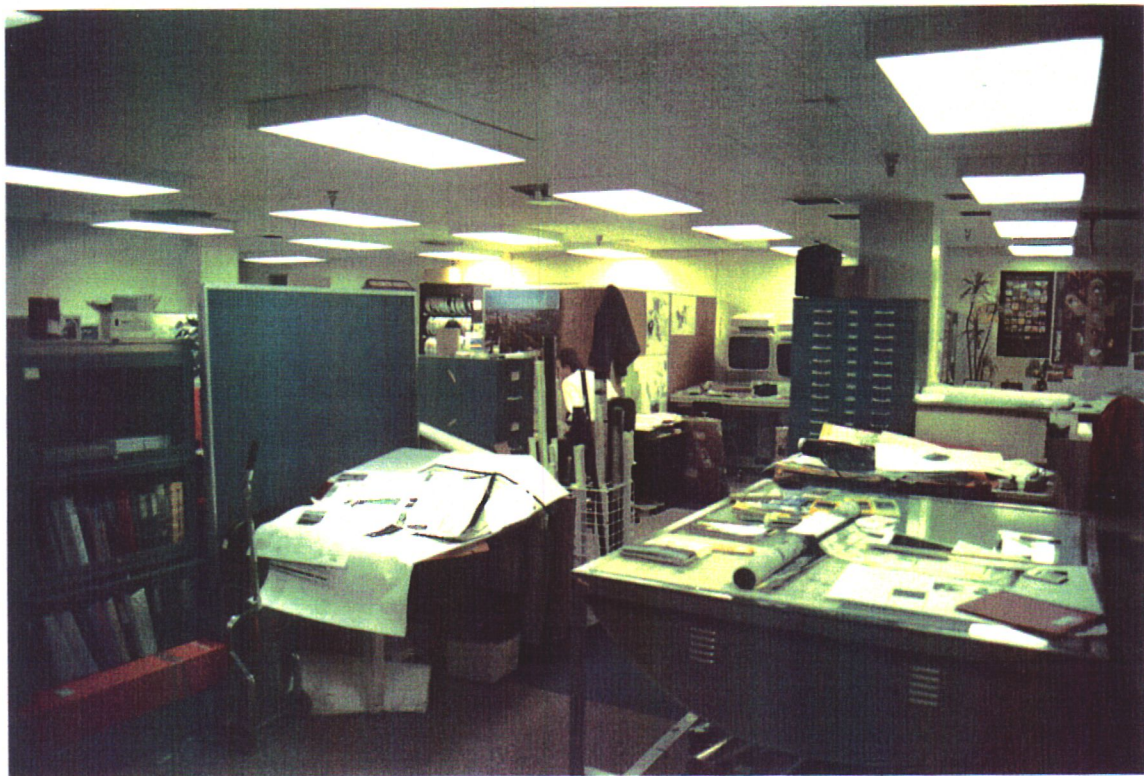
The existing ceiling system at the sixth floor is 1 x 1 acoustical tile glued to a suspended plaster ceiling. The existing ceiling system is old in appearance and prevents access to utilities above the ceiling. All other floors have new 2 x 4, 2 x 2 acoustical suspended ceiling systems. This remaining sixth floor ceiling will require replacement with new 2 x 2 suspended acoustical ceiling when new mechanical ductwork configurations are installed and structural upgrade is accomplished.

Sixth Floor Ceiling

Sixth floor ceiling system replacement will be required for the structural upgrade of columns and column caps for installation of new ductwork and lighting. The new ceiling will be attractive and allow access to above ceiling utilities.

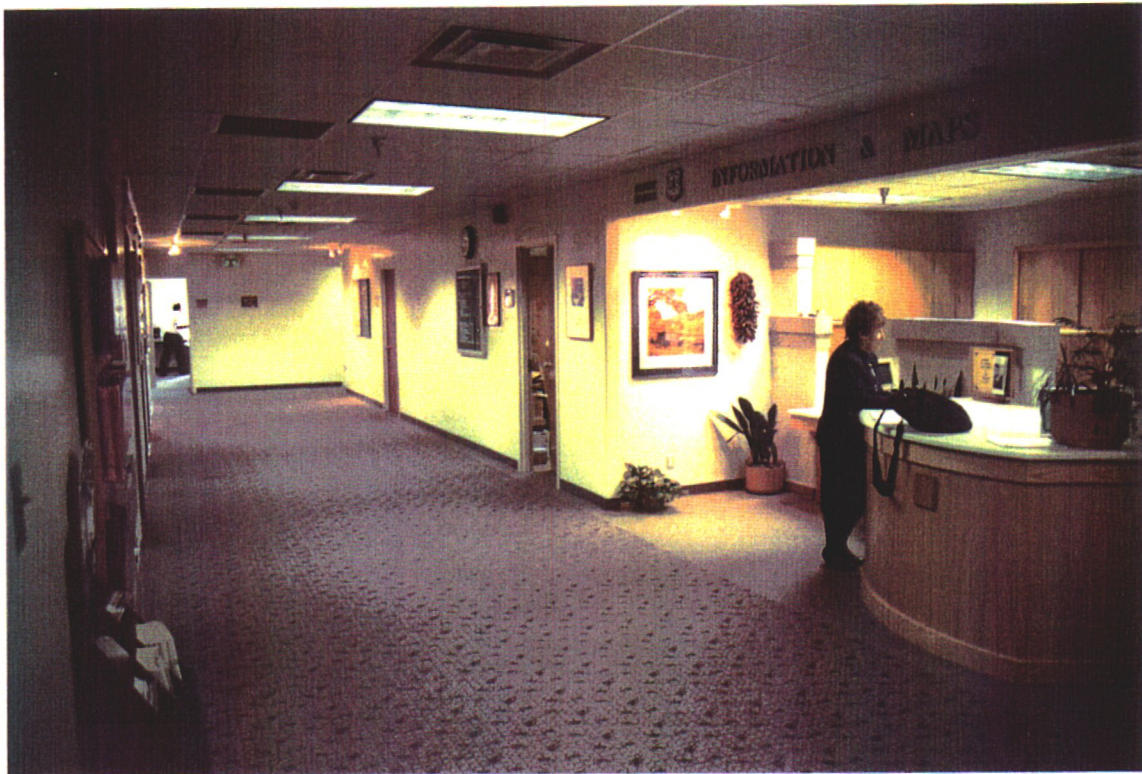
The existing ceiling system at these floors are two systems. The exposed lower system is a suspended tile with grid and above this system is an older suspended plaster ceiling. Ceiling system removal is required for structural upgrade of columns and to install new HVAC systems at all floors. The HVAC system is required for floor plan flexibility and reduction of energy consumption. See Work Items #515 - for scope of HVAC work. After HVAC removals and new HVAC installation, the new ceiling system may be installed. The existing lights will be retrofitted and reused.

Existing Ceiling System

Ceiling system replacement is required to accommodate structural repairs and new HVAC system installation at all floors.
